**LEVELTON**

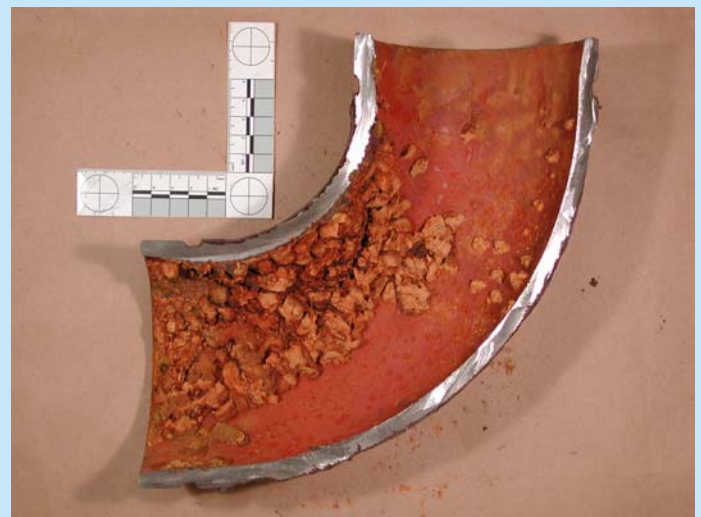
Tubercule formation due to microbiological activity observed on the internal diameter surface of a ductile iron fitting.

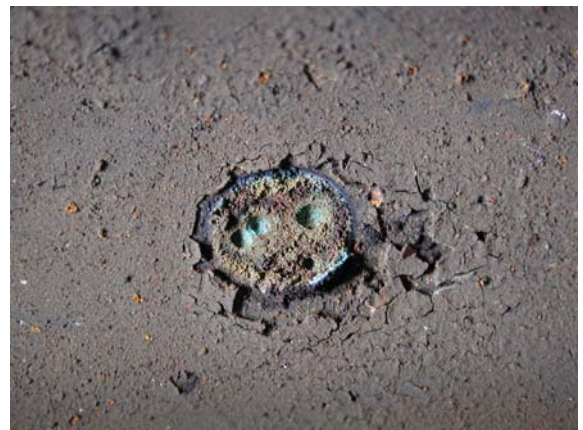
Cluster of corrosion pits observed beneath a tubercule on the internal diameter surface of a copper water distribution tube.
