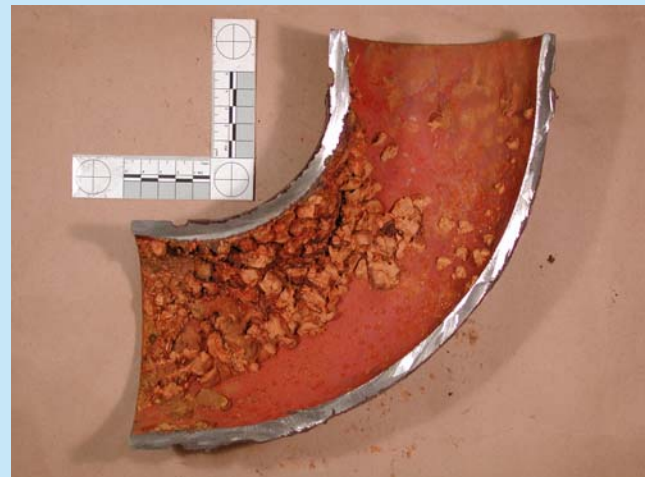
Tubercule formation due to microbiological activity observed on the internal diameter surface of a ductile iron fitting.

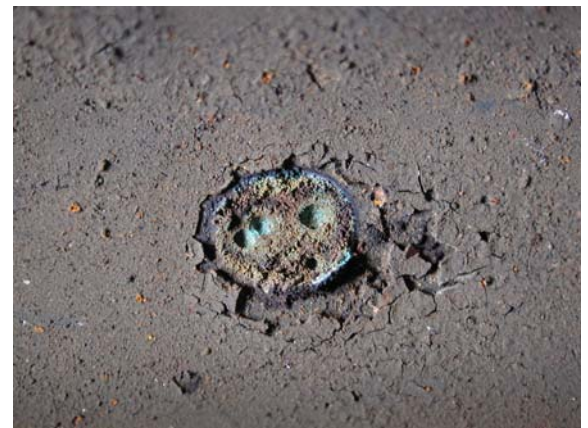
Cluster of corrosion pits observed beneath a tubercle on the internal diameter surface of a copper water distribution tube.
